Manhole Inspection Summary

Manhole # S43II_038MH

Insp Date: **7/2/09 9:09 AM**

Location Address: **1632 LANSING ST**

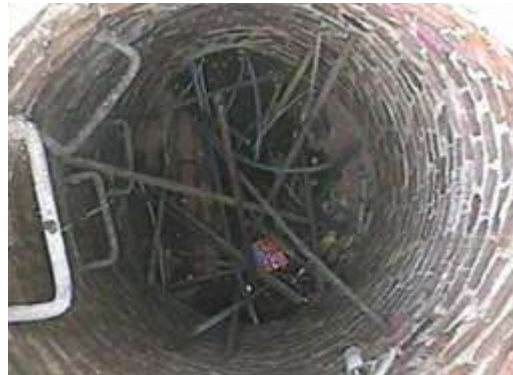
Top View

Condition: ☐ Sound ☐ Cracked ☐ Root Intrusion ☐ Deteriorated ☐ Leaks ☒ **Debris**

debris in channel

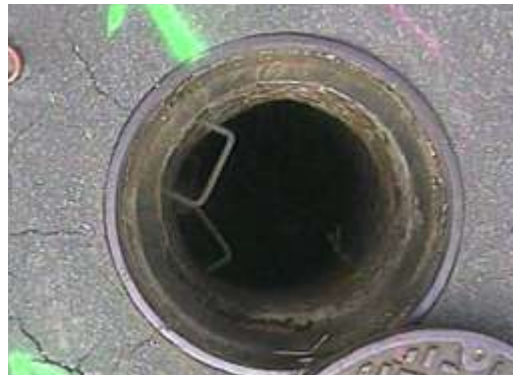
Defect 3

Offset: **1** (in.)

frame offset

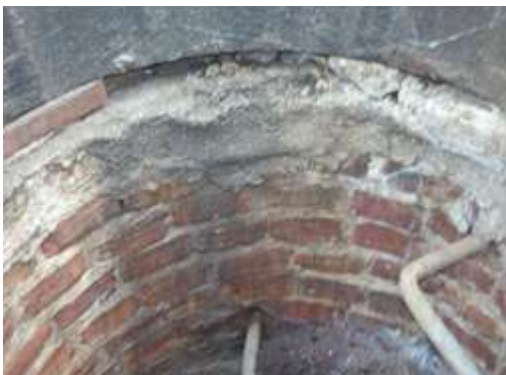
Defect 2

Condition: ☐ Sound ☒ **Cracked** ☐ Root Intrusion ☒ **Loose Brick** ☐ Deteriorated

Cracked chimney and loose bricks

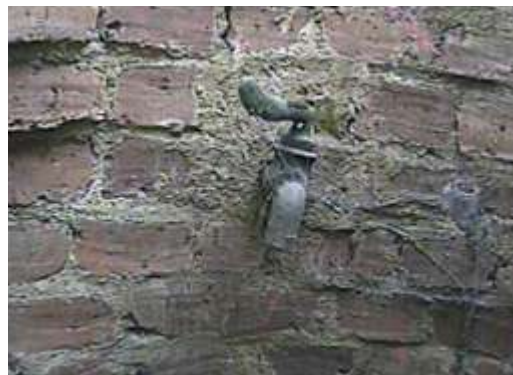
Defect 1

POSSIBLE ILLICIT CONNECTION OR
OLD GAS VALVE.

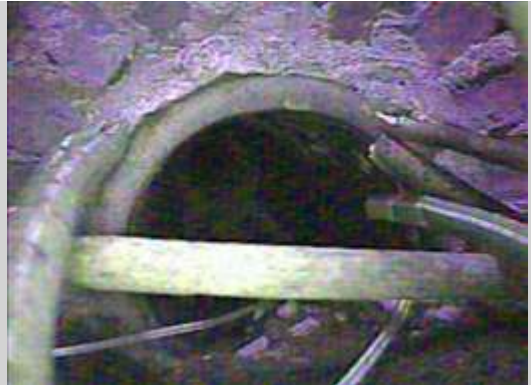
12 O'Clock Outflow

LOT OF DEBRIS

Deposits: ☐ None ☐ Mud ☐ Sludge ☒ **Debris** ☐ Grease

Silt Depth: **1** (in.) Deposits Extent: **Light**
